# Case study: neuropathic heel ulcer

# Foley L

Foley L. Case study: neuropathic heel ulcer. Primary Intention 2006;14(3):122,124-125.

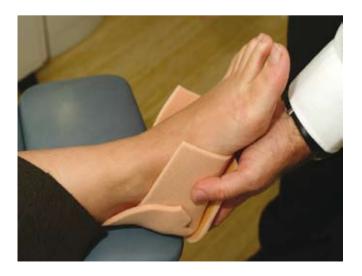
Figure 4. Heel offloading device, ready to be applied to the foot.

Appropriate offloading of the area was commenced to promote wound healing. Offloading proved to be problematic in this case given the need for the patient to work and care for three children. Rigid materials combined with splints or casts were therefore deemed unsuitable. Low density Plastazote (3mm) was cut for plantar protection, with 5mm moulded for the circumference of the heel. The plantar section was ground off the 5mm thickness so as to limit direct pressure on the area without using an aperture which could have caused herniation of the wound bed. Armstrong, Liswood & Todd <sup>3</sup> showed how pressure over an area can be redirected but increased at the periphery. Once the padding was consistently bandaged to the foot, the wound bed changed shape and dimension and commenced to heal from the base (Figures 2, 3 & 4).
