REVIEW

Re-imagining wound dressing trolleys and disposable wound dressing packs

Abstract

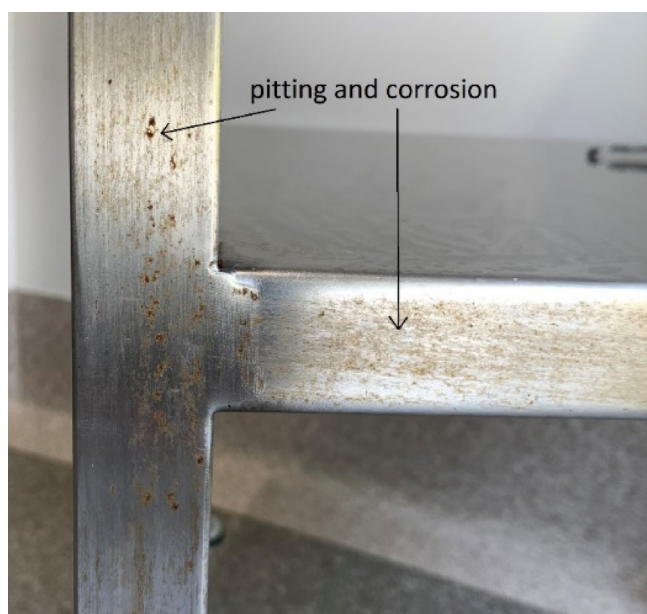
Figure 1. Corrosion on both vertical and horizontal surfaces following the grain of the stainless steel

In June 2021 a chance observation of 'rust-like streaks' on the predominately vertical surfaces of six of 21 (29%) WDTs in the surgical outpatient clinic raised concerns regarding the potential effects of cleaning agents and the quality of stainless steel in the WDTs (Figure 1). To explore the issues, in consultation with the infection prevention and control unit (IPCU), a quality improvement framework applying the elements of the plan-do-study-act (PDSA) cycle was registered. The PDSA cycle is widely accepted in healthcare improvement as a method for rapidly testing a change by planning it, trying it, observing results and acting on the learnings¹⁰. The key principle behind the PDSA cycle is to test on a small scale and to test quickly¹¹.

It has been reported in the trade literature⁹ that, over time, stainless steel can become stained or discoloured. This effect has been reported on structural stainless steel most commonly within 5kms of coastal areas and progressively worsens closest to the marine source, and in the presence of surface corrosives^{9,17}. This discolouration of surface stainless steel tends to follow the 'grain' of the finished surface and is referred to as 'tea staining'. The presence of tea staining indicates corrosion of the stainless steel, is rarely seen as a problem indoors unless exposure to corrosive deposits, and is considered a cosmetic rather than a structural issue¹⁷.

Within the health sector there is little data in the literature of the rate of stainless steel corrosion on clinical furniture like the WDT. It is, however, known to occur when lower grade stainless steel is subject to heat and chemical disinfection, or both, in sterilising departments⁹. In the clinical environment sodium dichloroisocyanurate (NaDCC), a proprietary tablet diluted in water, is used for routine cleaning and disinfection of clinical furniture and medical equipment. In a series of bleach and NaDCC exposure tests on grades 304L (Grade 304L denotes a lower carbon content, usually with no difference in corrosion resistance) and 316 stainless steel coupons¹⁸ demonstrated the corrosive effects of bleach solutions on medical device disinfection. The NaDCC solutions did not show corrosive effects on either grade of stainless steel. The substitution of NaDCC for bleach¹⁷ is considered a safe alternative¹⁹ and can reduce the frequency of equipment replacement and the costs and can maintain the required levels of disinfection¹⁸.

Steps to minimise the corrosion risk to stainless steel include selecting the appropriate grade of stainless steel for the specific need¹⁷. Recommendations for a cleaning solution on stainless steel include the avoidance of chlorides and bleach, pH levels less than 5 or greater than 12, and boiling water above 60°C²⁰. The use of chloride-based chemicals for disinfection in healthcare settings may contribute to the reduced resistance appearing as damage to the unknown grade of stainless steel WDTs and other equipment over time.

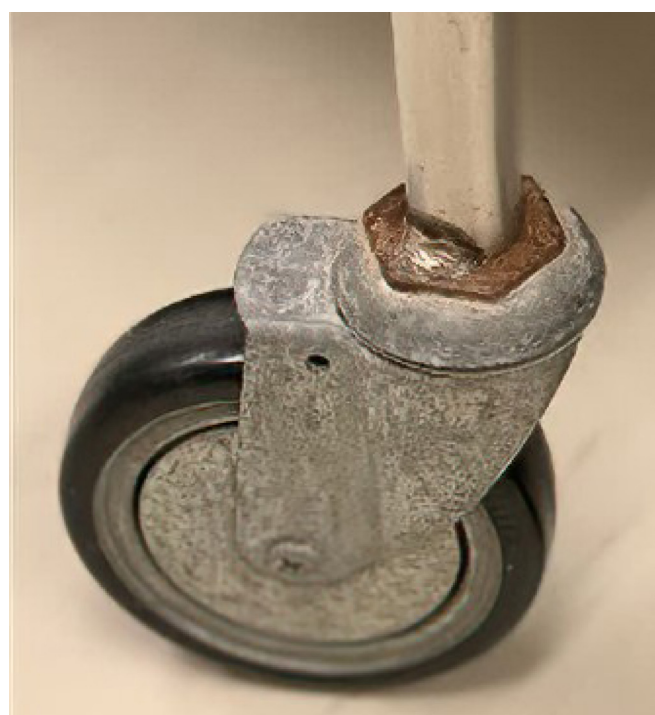
Figure 2. Rust/corrosion on galvanised forks and attachment point to WDT

The facility-wide audit identified 63 WDTs, with a variety of seven styles and sizes in use (Table 1). Key issues identified included signs of corrosion on 40% of the galvanised forks/castors (Figure 2), brittle plastic brakes, and the possible effects of chloride-based cleaning products on vertical surfaces on 10% of WDTs. There were a smaller number of WDTs with one or more drawers, partially or fully filled with consumables, with rails on the top and the second shelf. There were no labels identifying the grade of the stainless steel or manufacture date on any of the WDTs; this appears to be a universal practice.

Recurrent themes from the key clinicians indicated brakes were not considered necessary as WDT, by definition, need to be mobile and in healthcare settings floor surfaces are usually level. Stainless steel forks and castors were advised to minimise corrosion to the galvanised sets usually affixed on purchase. Drawers were eliminated as they pose a risk from accidental fluid spills, inviting access mid-procedure, risking contact contamination and the overstocking of

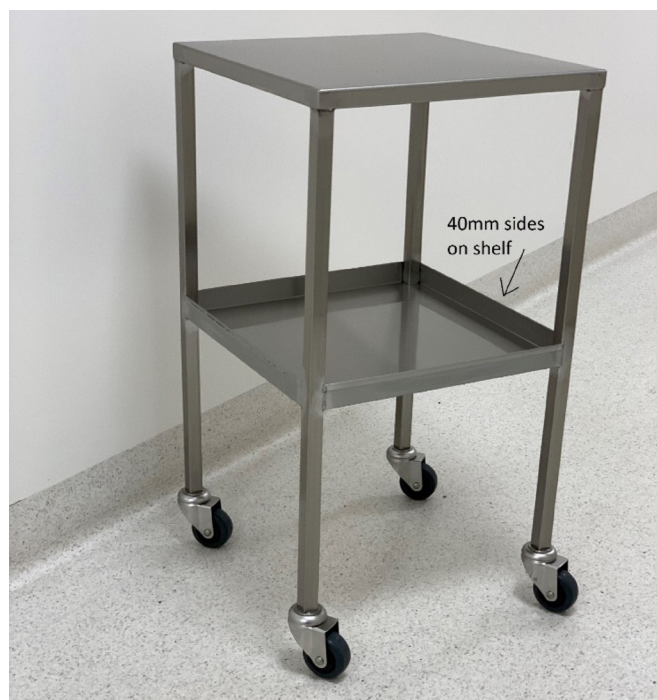
Figure 3. The recommended grade 316 stainless steel with a 40mm high shelf

Criteria	Specifications
Stainless steel	Grade 316 for all flat surfaces and legs/posts
Fully welded joints	All exposed gaps to gravity/waterfall (visible from above)
Height	900mm, including castors
Platform	490x490mm safety edge
Shelf/tray	490x490mm with 40mm sides x 4 internal joints welded, safety edge
Castors/forks/wheels	4 swivel 100mm castors (no brakes) stainless steel – rubber wheels
Manufacturer	Grade of stainless steel, name of manufacturer and date manufactured securely attached to underside of WDT
